2nd Addendum letter for MOD - TPS

ECS Project # 03-216630.00

Re: Response to Questions- Risk Based Site Cleanup and Disposal Plan  
Thomas Prince School  
170 Sterling Road  
Princeton, MA 01541

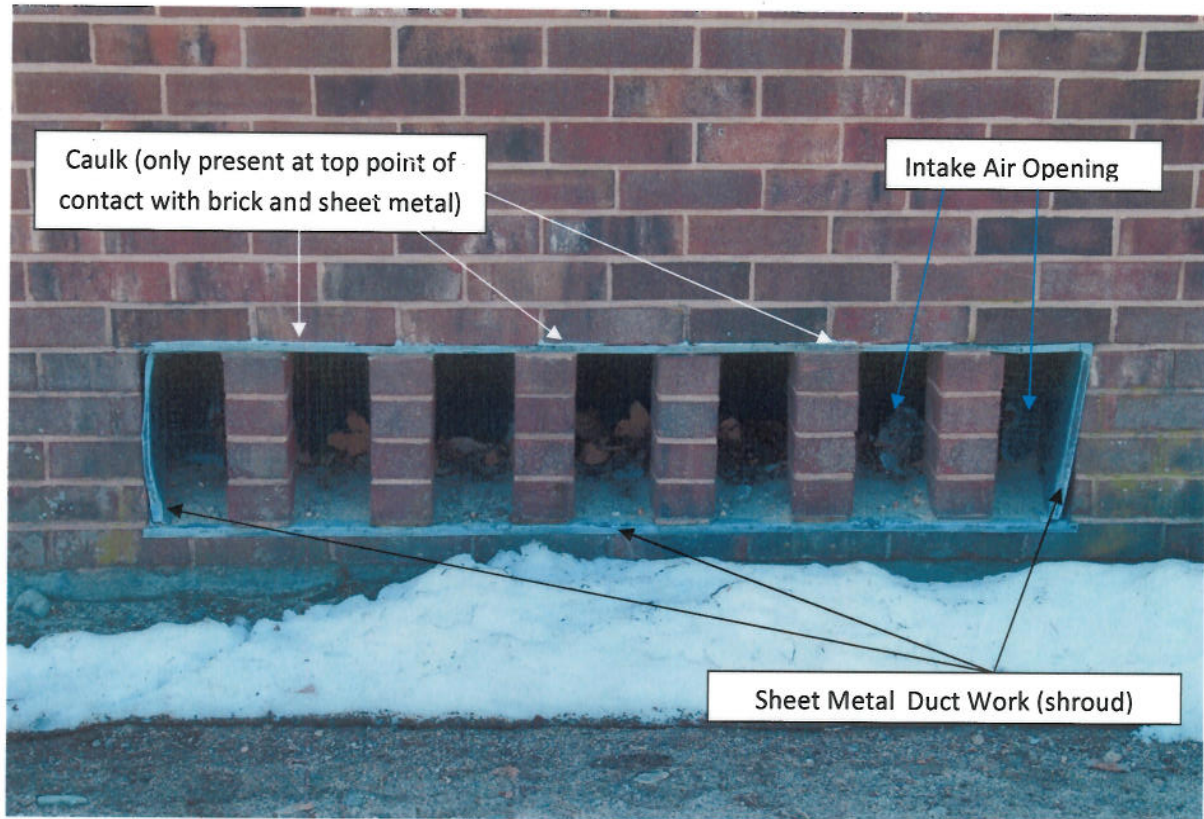
**Air Intake Vents – 100 Wing Classrooms** – Prior to and following the meeting which I attended at the school yesterday, ECS and TEI closely inspected the air intake vents for the subject 100-Wing classrooms. See the attached photo, Figure 1, for a depiction of a typical vent for the subject 100-Wing Classrooms.

A typical vent opening is 54 inches wide by 8 inches in height. It is located on the bottom vertical side of the building and does not contain a louvered plate over its front but rather is open in the front, divided by several, eight inch high by two inch wide brick columns. Sheet metal ducting lines the interior of the vent and is supported in the front opening by the brick columns. The sheet metal ducting extends contiguously into the unit ventilator. Where it comes in contact with the exterior brick face of the building facade, it is crimped at a 90° angle to overlap the exterior building brick face by approximately ½ inch on all four sides. It was determined that caulking is only present at the top of the ducting of each exterior vent opening where the sheet metal duct work comes in contact with the brick, i.e. the side and

bottom joints do not contain caulk and no remnants of caulk were observed. The unit ventilator draws its room dilution air from this vent opening.

**Figure 1: Typical Exterior Vent Structure: 100 Wing Classrooms.**

Following is the plan, in order of operation, to address these exterior vent openings as part of the previously submitted modification.

- 1) All exterior caulk associated with the vents will be removed (this will be approximately 22.5 linear feet based on caulk only being present at the top of the vent as recently confirmed);

- 2) The ½ inch of sheet metal that is crimped at a 90° angle parallel with the brick face, on all four sides, will be bent back so that it is perpendicular to the brick face. This will provide access to the small gap between the brick and the sheet metal for cleaning and epoxy coating;

- 3) The gaps between the sheet metal and brick will be suctioned with a HEPA vacuum to remove loose residual debris that may be present;
- 4) The readily accessible inner surfaces of the duct work, at and within the opening of the air vent, will be cleaned via HEPA vacuum to remove dust, dirt or debris;

- 5) The readily accessible surfaces of the sheet metal duct work and brick that were in contact with the caulking will be cleaned via wet wipe methods;

- 6) The readily accessible inner surfaces of the duct work, at and within the opening of the air vent, will be cleaned via wet wipe methods;
- 7) Two coats of epoxy will be applied to the accessible surfaces of the brick to a distance of eight inches (four brick widths) from each side of the vent, consistent with the previously approved distance for the 200-Wing rooms). In addition, two coats of epoxy will be applied to the brick surfaces that are perpendicular to the brick face wall at a distance of approximately ½ to 1 inch at the corners of the brick surface that extend below the metal duct work;

- 8) The edges of the sheet metal duct work, adjacent to the exterior brick building façade, will be bent back to their original positions such that approximately ½ inch of sheet metal will cover the edges of the epoxy coated brick at the openings of the air vents.

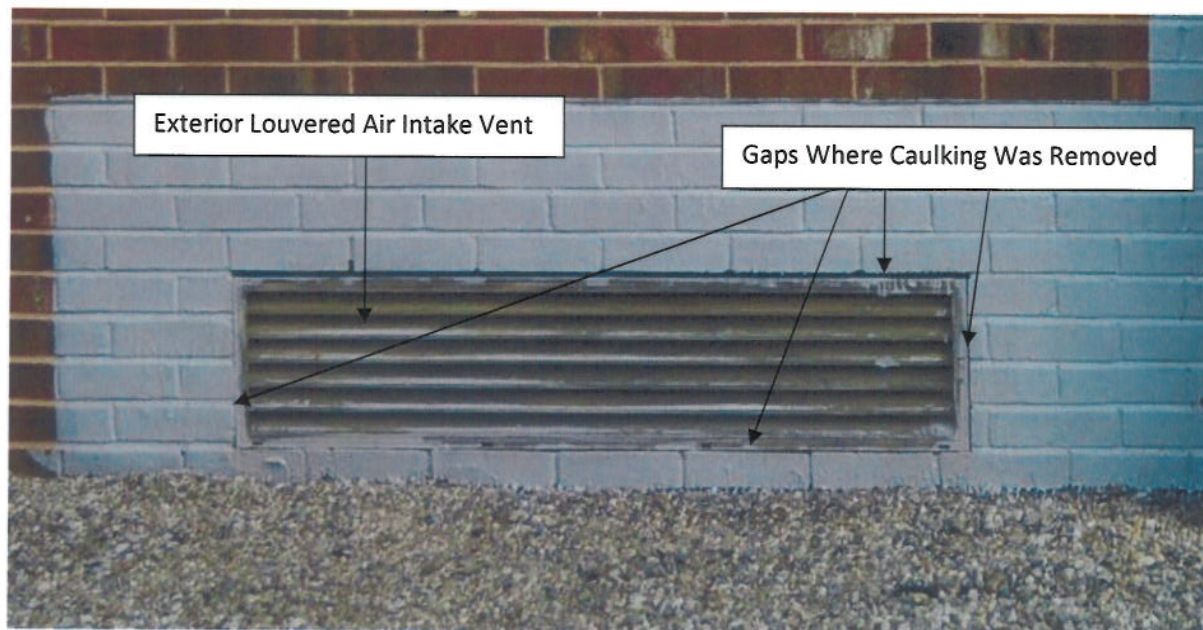
**Air Intake Louvered Vent Covers – 200 Wing Classrooms** – As we discussed on Tuesday, the approved Risk Based Site Cleanup Plan for the 200-Wing exterior metal louvered air intake vent covers provided for the removal and replacement of the covers (section 4.4, bullet one of the February 13, 2012 Risk Based Cleanup Plan). Due to an oversight, the vent covers were not removed. Following the meeting at the school yesterday, ECS and TEI closely inspected several of the exterior louvered air intake vent covers for the 200-Wing classrooms. Review of field notes and a discussion with the TEI Field Supervisor were also performed to confirm the actions that were taken to address the metal louvered vent covers. Based on a review of available information and discussions with TEI, it was confirmed that the following actions were taken in response to the exterior louvered vent covers:

- a) All visual exterior caulking was removed;
- b) The outer sides of the louvered vent covers (sides facing away from the building) had been cleaned via HEPA vacuum and wet wipe methods (the inner sides of the vent covers (facing the building) had not been cleaned);

- c) Two layers of epoxy were applied to the brick face within 8 inches of each side of the louvered vent covers.

**Figure 2: Typical Exterior Louvered Vent Structure: 200 Wing Classrooms.**

As a modification to the plan, ECS proposes to collect three wipe samples, per required EPA methodology, and submit the samples for analysis via EPA Methods 3540C and 8082 for PCB's. It is proposed that one sample each be collected from three of the six existing inner sides of the louvered vent covers. If the result of a wipe sample for a particular louvered vent cover is greater than 1 ug/100cm<sup>2</sup> PCB, that louvered vent cover will be removed and cleaned via HEPA vacuum and wet wipe methods or replaced with a new cover.

If the cleaning option is selected, upon cleaning, another wipe sample will be collected from the inner side of the vent. If the sample result remains greater than 1 ug/100cm<sup>2</sup> PCB, the louvered vent cover will again be cleaned via HEPA vacuum and wet wipe methods or replaced with a new cover. Any cover that produces results less than 1 ug/100cm<sup>2</sup> PCB will remain in place or be reinstalled (if it was removed for cleaning and re-sampling). This procedure will continue until either a result of less than 1 ug/100cm<sup>2</sup> PCB is obtained for a particular vent cover or until a new cover is obtained. The decision to resample or replace a cover will be made by the Town of Princeton. See the attached photo, Figure 2, for a depiction of a typical exterior louvered vent cover for the 200-Wing Classrooms.
